TRACING THE IMPACT OF BANGALORE'S URBANISATION ON ITS WETLANDS WITH A CASE STUDY OF SAMPANGI LAKE

¹FATHIMA SAMANA S & ²RAJESH GOPINATH

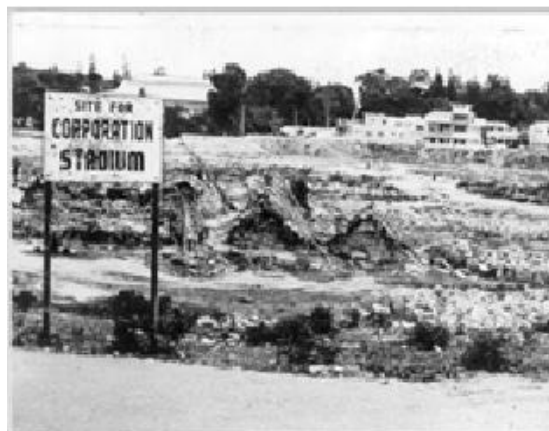
Figure 9: Sampan Sampangi Tank Bed for Stadium Construction. (Ref. www.cscsarchive.org)

The above unraveled pattern can be distinctly observed in the case of Sampangi tank (figure 8) as well. The lake was initially encroached upon for Kanteerva (Corporation) Stadium (figure 9), as a policy decision by the government. The highlighted portion within figure 9 depicts the historical extent/area in 1877.
