ROCK BURST CONTROL AND PREVENTION IN MUFULIRA MINE

ABSTRACT

KEYWORDS: Rock Burst; Geological Factors; Inspection and Control & Mufulira Mine

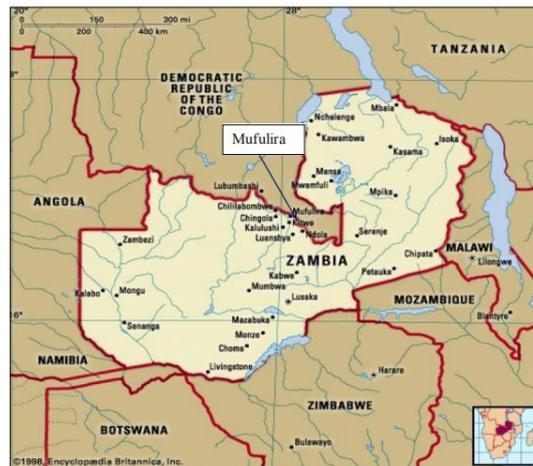
Figure 1: Depicting the Locality of Mufulira Mine on a Regional Scale.

The Mufulira Copper Mine Site (Figure 1) is situated in the northern part of the Zambian Copperbelt, about 10km south of the border with Democratic Republic of Congo (DRC). It lies on the north-eastern side; of the Kafue Anticline approximately 1250 m above sea level. Mufulira Mine falls within mining license LML 32 which covers an area of 19,101 hectares, with surface rights extending over 16,100 hectares.

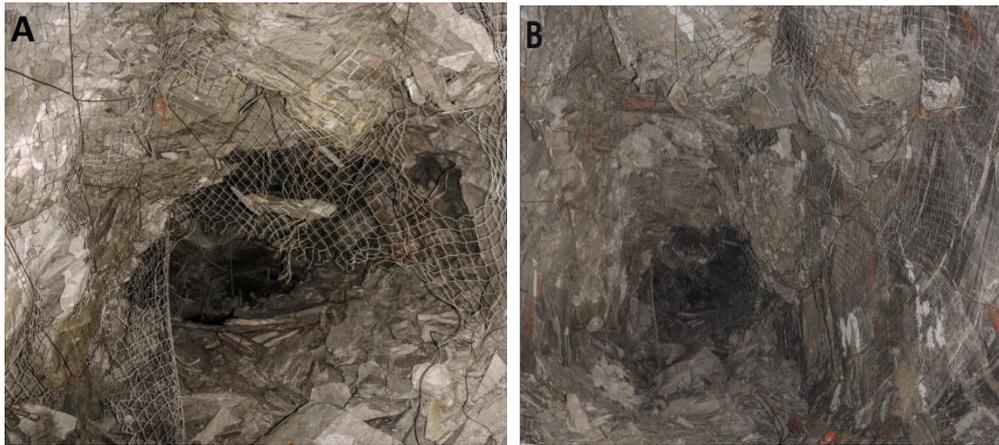
Figure 2: Mufulira Mine Rock Burst at Level 1157 August 2014.

Over the years Mufulira mine has experienced ground hazard accidents such as rock burst that have rapidly increased in frequency, threatening life and causing financial losses. For example, In August 2014 a series of rock burst at 52 block occurred causing tunnel collapse (Figure 2). On 16 January 2018, an M 2.8 rock burst occurred in the 1440-metre level of mining drive, which have caused in 13 m of damaged rock mass and about 71 m³ of rocks being ejected to the space of mining face. In addition, it was found that there is a general poor ground conditioning within the mine. For example, on the 6th June 2016, a rock mechanics investigation reported poor ground condition in 64P2 mining drive on 1423 m was carried out and the following was observed; The area was currently in a high stress environment (215 MPa) according to the previous numerical modelling results; no popping sounds were heard at the time of the inspection. However, stress induced but structurally controlled damages were observed on both sidewalls; two ends (64P2 Stub Xcut North and 64P2 Xcut South) were blasted on 05 June 2016 in the same shift creating an unstable cross junction and no primary ground reinforcement was being installed after blasting. To address those situations, Mufulira mine should adequately employ the use of micro seismicity monitoring technology, and a few rock burst preventative measures are to be adopted in order to strengthen the risk management.

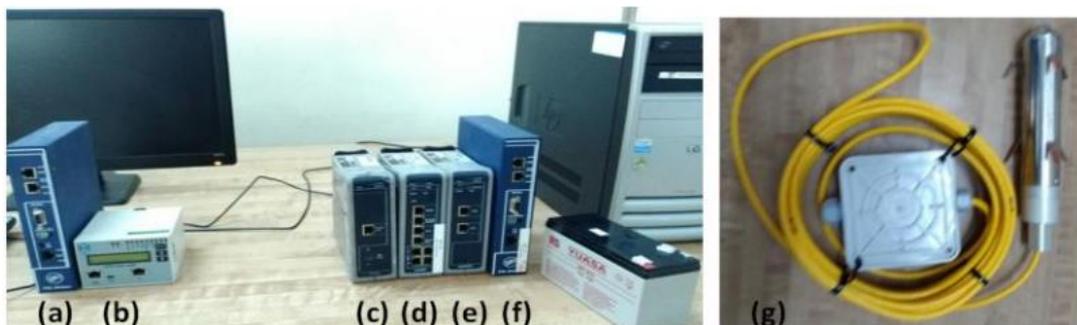
Figure 3: Seismic Monitoring Components [a: Digital Subscriber Line Modem (DSL), b: Analogue Time Unit (ATU), c: Uninterrupted Power Supply (UPS), d: Net Signal Processor (netSP), e: Net Analogue Digital Converter (netADC), f: Digital Subscriber Line Modem (DSL), g: Geophone].

Mufulira mine operates a seismic system which was installed in 1994, when the mine became prone to seismicity due to poor or improper mining sequencing. Closure pillars were the main cause of seismicity on the mine. In recent times the mining sequence has changed, mining being conducted from a central location and retreating or advancing towards solid abutment. The main triggers have been associated with remnant pillar collapse, deeper mining and associated high abutment stress, and reclamation. Currently the system is operating with 12 sensors and the mine is divided into seven polygons for specific monitoring of micro-seismicity in different areas. The installation units of the seismic monitoring system and locations are in Figures 3 and 4.

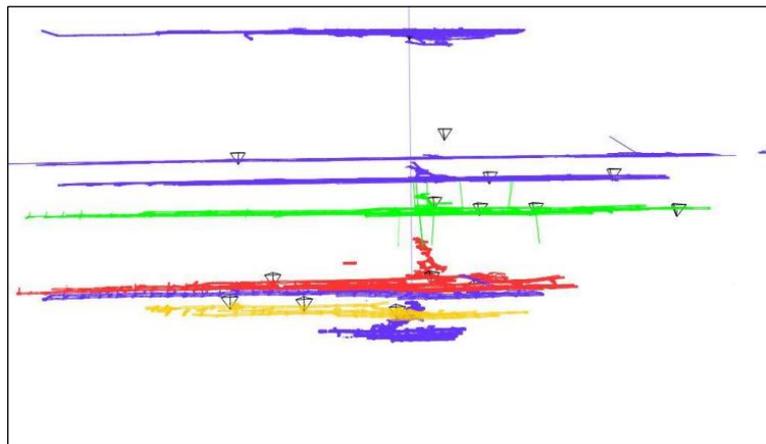
Figure 4: Mufulira Seismic Network (Prisms Indicate Geophone Locations).

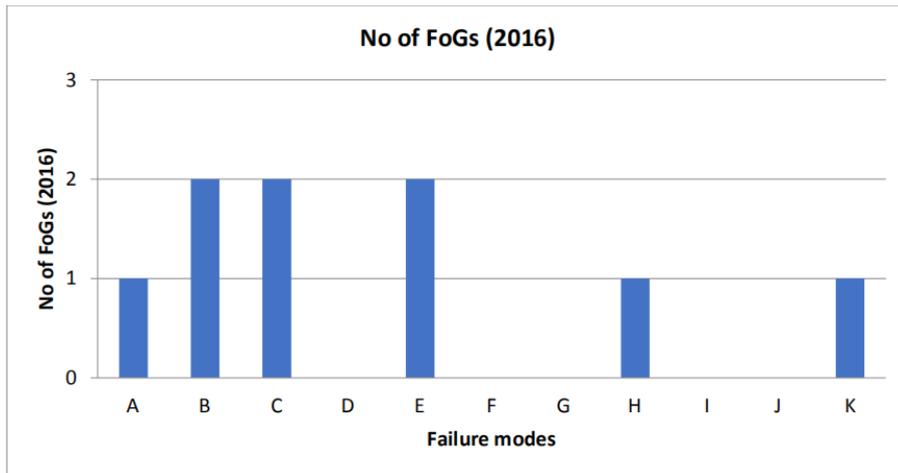
Figure 5: 2016 Falls of Ground Analyses.

In order to show the effect rock burst control methods applied in Mufulira mine, an analysis of the recent falls of ground was conducted. Failure modes were categorized in order to ease interpretation (Table 2). The detailed failure modes were shown in Figures 5 and 6, which demonstrating the successful prevention and control of rock burst hazard in the mine.

From the analyses, there were 9 falls of ground which occurred in 2016. For the 2017 year to date, 3 falls of ground has occurred. In 2016, the majority of falls of ground were stress related. Either as a result of seismic events, or stress fracturing. For this data set, the application of the reinforcement/support elements mentioned in Table 1, and keeping a distant to unsupported ground for workers has evidently relieved the ground fall hence reducing risk of injury and damage of machinery.

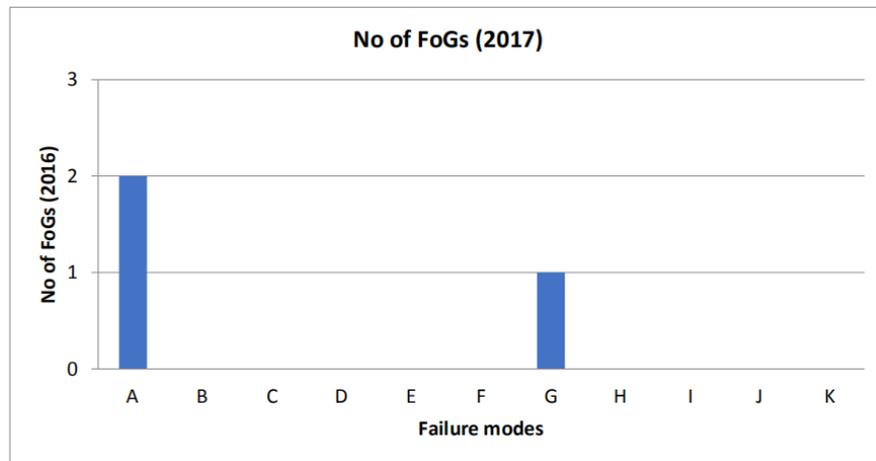
Figure 6: 2017 Falls of Ground Analyses.
